FEASIBILITY STUDY

Burlington Police Department
Burlington, Iowa

January 23, 2015

Klingner & Associates, P.C.

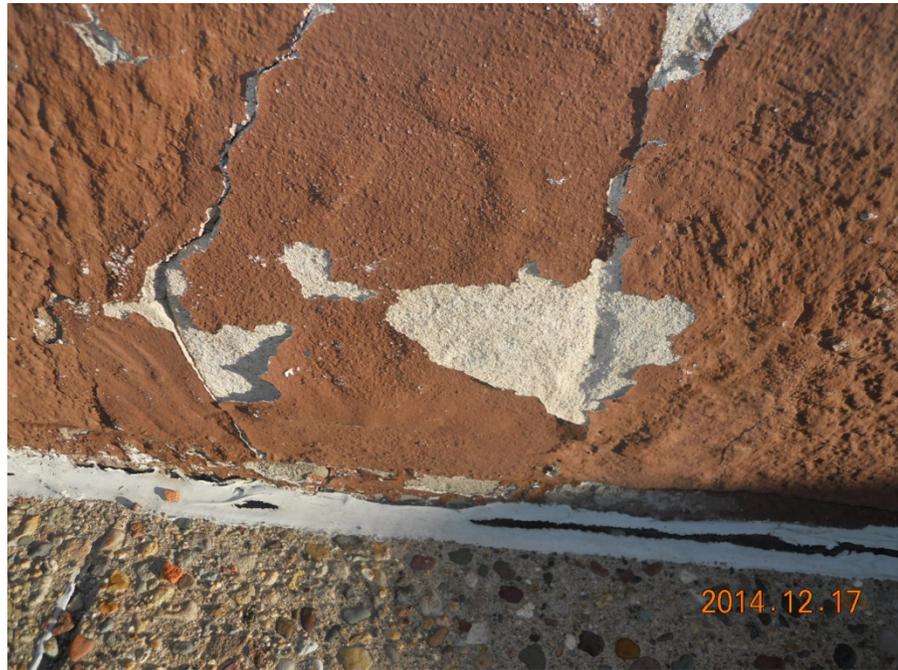
Image 1.1.1b

Deterioration of
foundation wall
Men's locker room

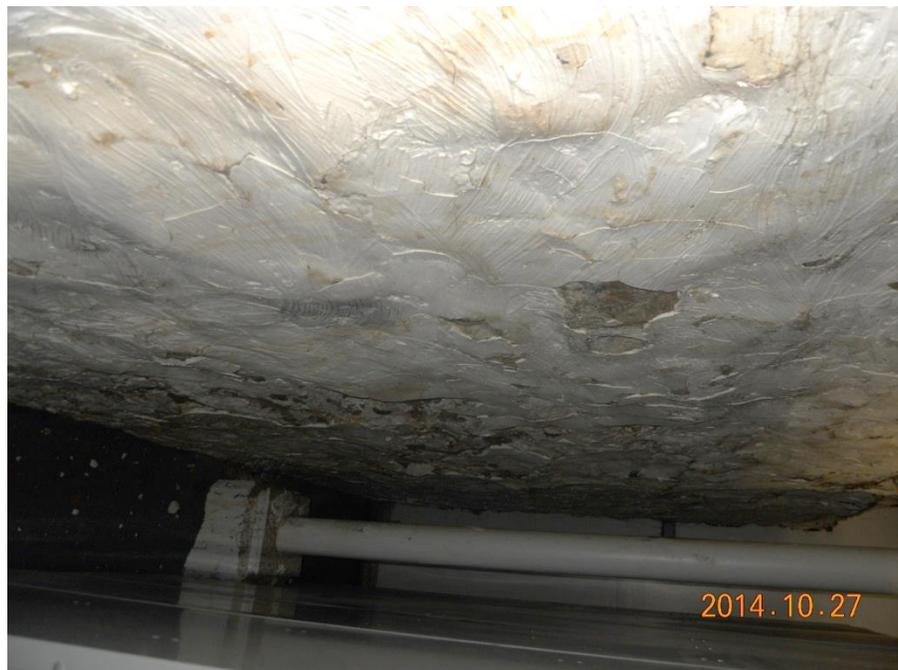
Image 1.1.1c

Deterioration of
foundation wall
North wall, basement

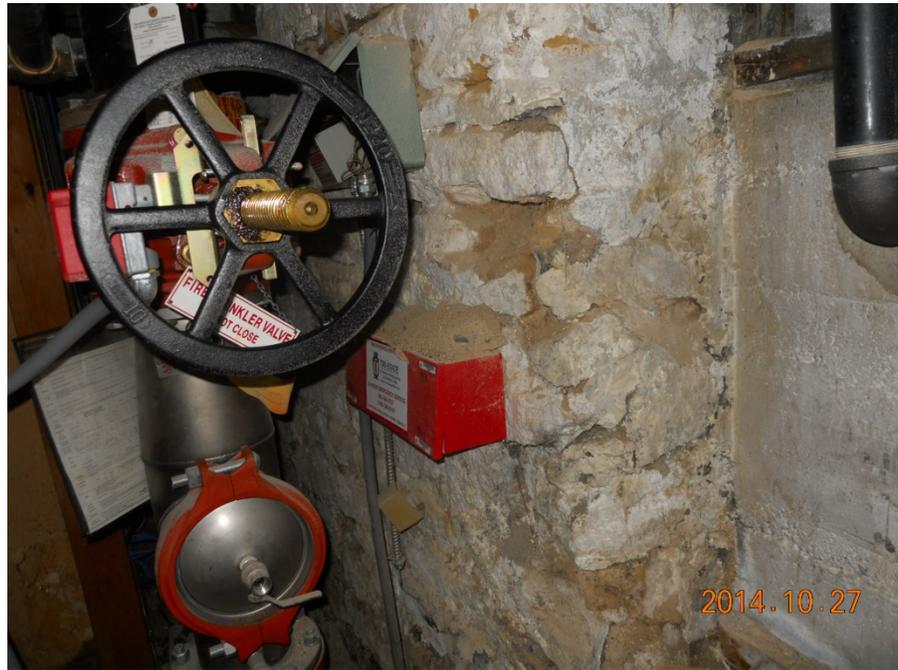
Image 1.1.1d

Deterioration of
foundation wall
Sub-basement

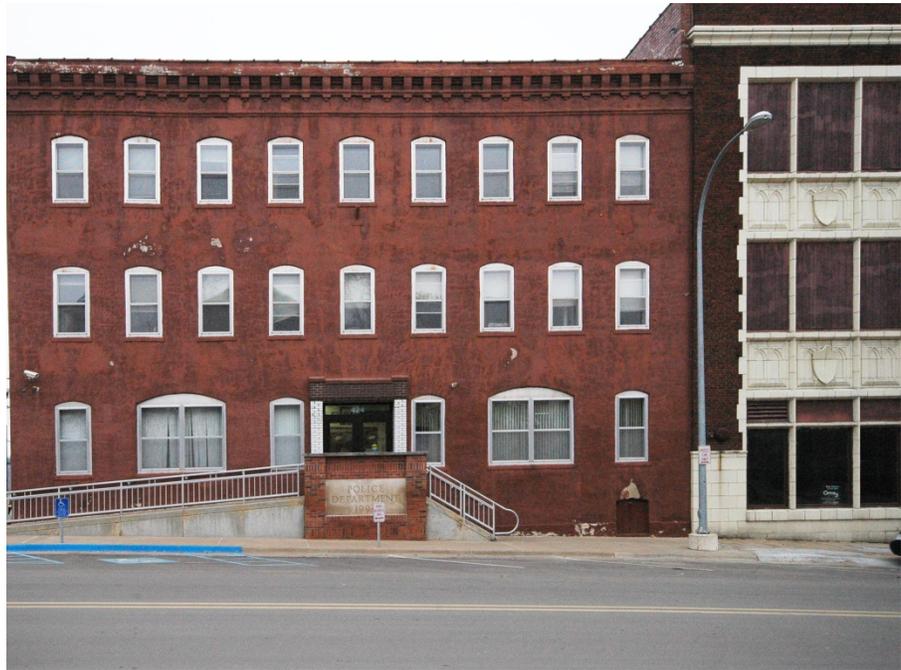
Image 1.1.2b

The front façade, facing west, has a 1/2" cement based parging. Based on historical photographs, it appears the parging was installed sometime before 1971 (Image 1.0b). There is evidence of several patches as indicated by a change in the parging texture (Image 1.1.2b). The majority of the patching occurred under the 2nd and 3rd story windows. No drip ledge is under the limestone window sills and the parging has resulted in the sills being nearly flush with the wall. This may be the cause of concentration of moisture under the windows.

Patches in parging
West Façade

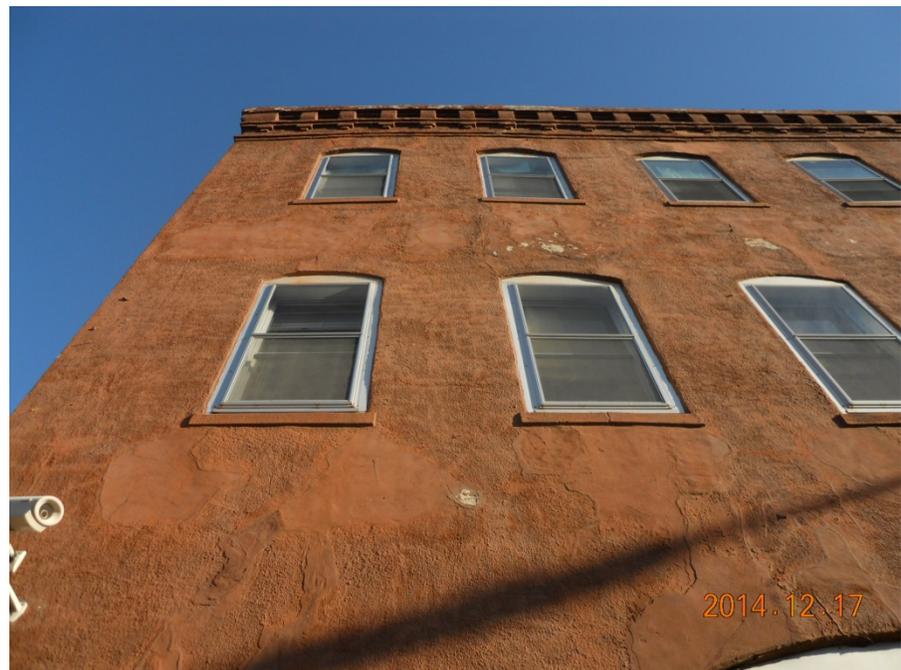
Image 1.1.2c

The parging has been painted to match the color of the existing bricks. Some paint is delaminating from the parging which would indicate trapped moisture from the installation of a non-breathable paint finish. The location of the missing paint seems to confirm that this is a moisture problem. The paint and parging deterioration is most noticeable near the parapet at the top of the building, under the windows, and at the foundation (Image 1.1.2c-e).

Deterioration of parging
West Façade top of wall

5 to 10 Year Plan – Remove all the loose parging and patch. Investigation of the existing paint is recommended to determine what type of paint is present. If it is a non-breathable type then removing it and applying a breathable coating should be considered. If more than 50% of the parging is loose, remove all parging and outer wythe of brick and relay with new brick.

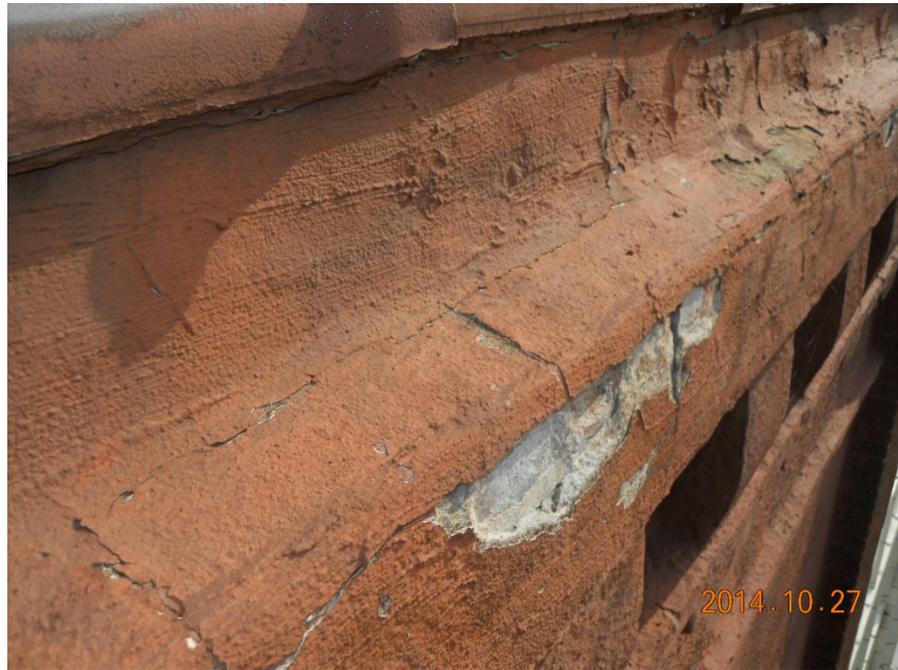
Image 1.1.2d

Deterioration of parging
patches
West Façade

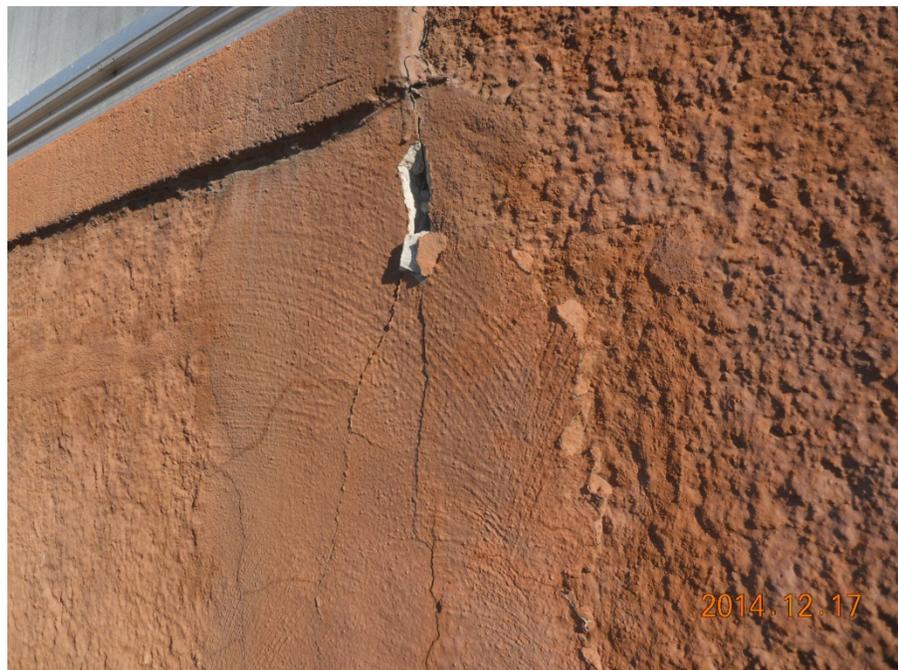
Image 1.1.2e

Deterioration of parging
West Façade bottom of
wall

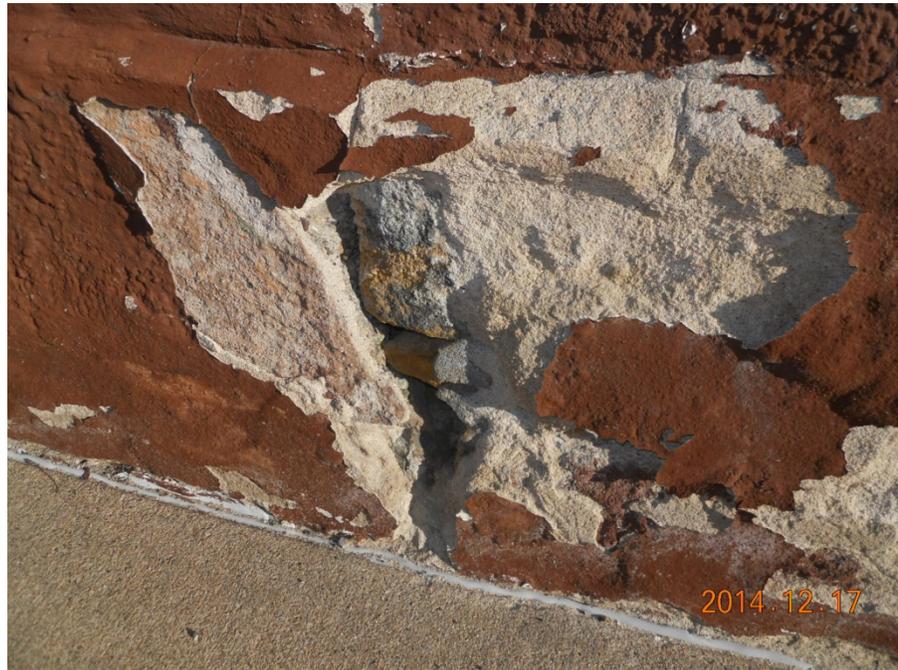
Image 1.1.2f

Near the basement window on the south end of the front façade, parging has been removed revealing the shape of the brick underneath (Image 1.1.2f). The brick are severely damaged which could be the result of “roughing-up” the brick with a hatchet prior to the application of the parging. No metal lathe was used to reinforce the parging or to secure it to the existing wall. Modern day parging installation often includes metal lathe as an integral part of the system.

Damaged brick
West Façade

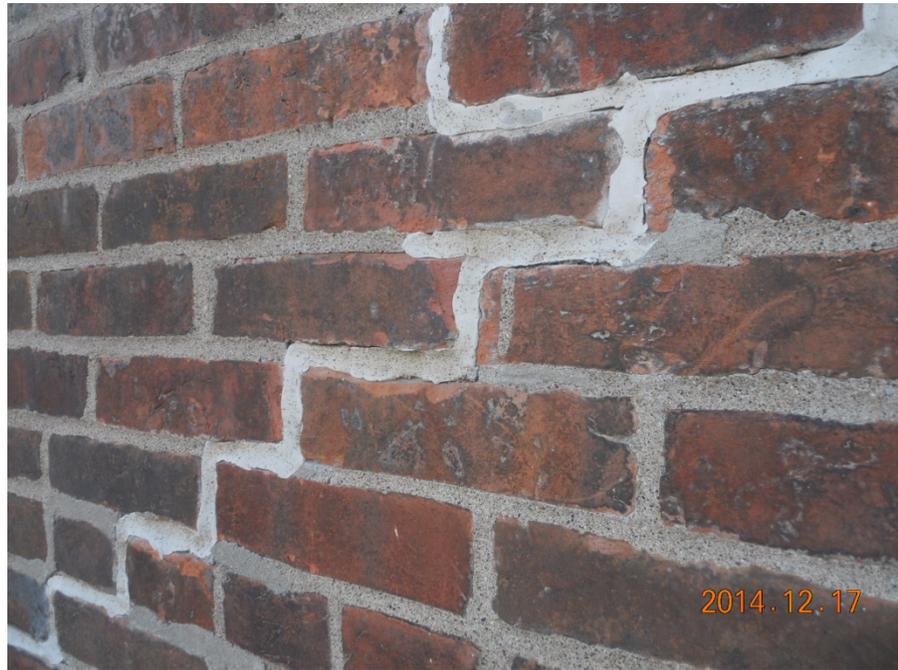
Image 1.1.2j

Brick damage can be spotted by a brighter orange face (Image 1.1.2j). The bright orange brick is the softer interior of a brick after the hard kiln fired face has spalled off. This brick will continue to deteriorate unless the hard mortar is removed and breathability of the wall is restored.

Brick spalling

5 to 10 Year Plan – Repair coping cap and add thru - wall flashing to limit water infiltration into the wall. Remove caulking in the cracks and replace with appropriate mortar. Repoint as needed (assumed 20% of the wall surface).

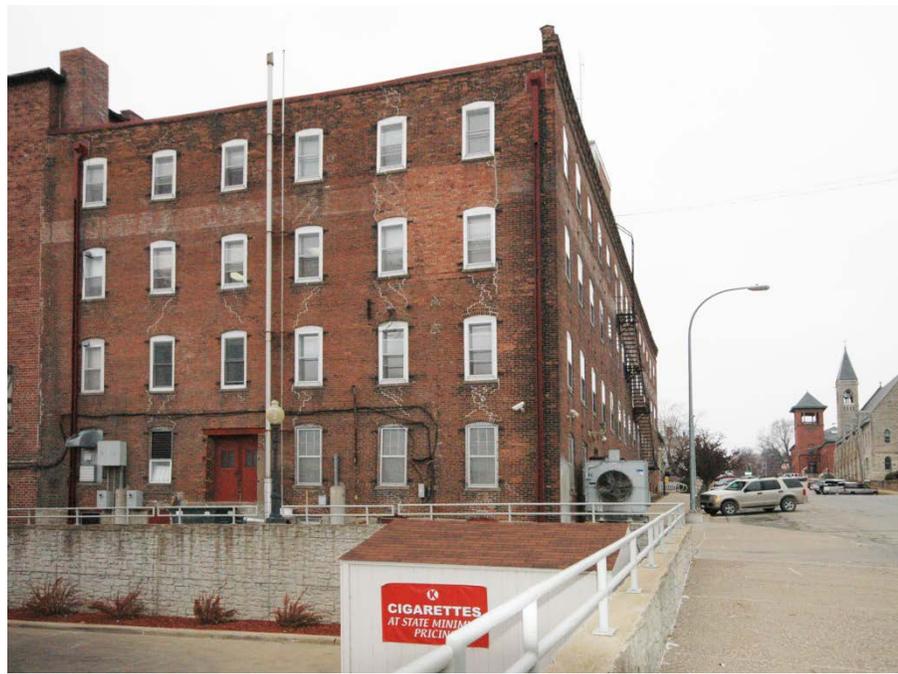
Image 1.1.2l

The east façade has the most structural cracks. There is a severe bowing between the 2nd and 3rd floor windows on the North end. The Wall here is approximately 3” out of plumb from the top of the building. The most severe bowing is occurring where the brick was previously replaced. There is also bowing vertically from the basement to the third floor along the far north column of windows. Inside the building, the floor is over 2 ½” away from the wall. 15 separate areas of spider-webbing around the windows are evident from the light grey sealant that has been installed (Image 1.1.2l).

Caulking in place of
mortar

5 to 10 Year Plan – Repair coping cap and add thru - wall flashing to limit water infiltration into the wall. Remove caulking in the cracks and replace with appropriate mortar. Repoint as needed (assumed 20% of the wall surface).

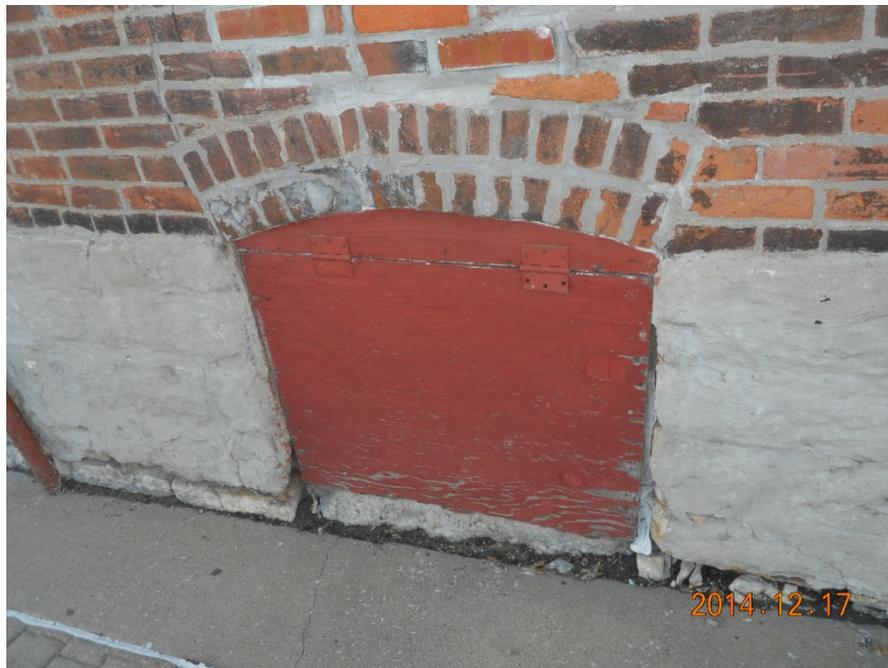
Image 1.1.5b

These openings are located on the lower level along the Northeast corner. They consist of the original wood jamb and wood sash with a screw applied aluminum exterior storm window. The paint is cracking and peeling off the wood and the sealant around the jamb is cracked, falling out, or missing. The storm windows seem to be in relatively decent condition (*Image 1.1.5b*).

Peeling paint, missing
caulking
Window Type II

5 to 10 Year Plan – Check and repair all windows, frames, and storms on an as-needed basis. Check, repair, or replace all exterior sealant on all window types. Repair and repaint all exposed wood. Make sure that all storms are securely fastened to exterior. Refasten interior cover caps that have come loose

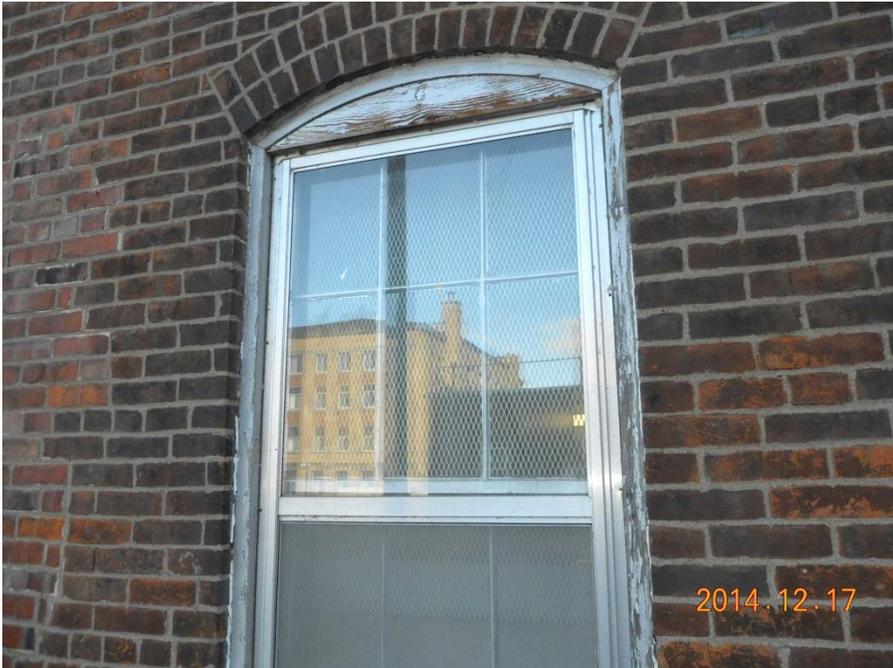
Image 1.1.5c

Frame separation
Window Type III

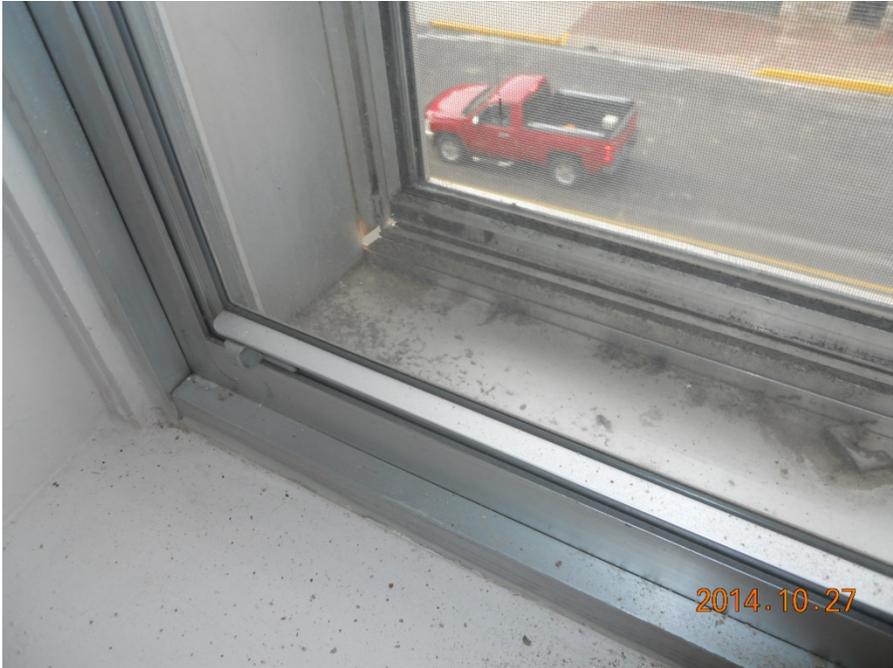
Image 1.1.5d

Broken Glass
Window Type III

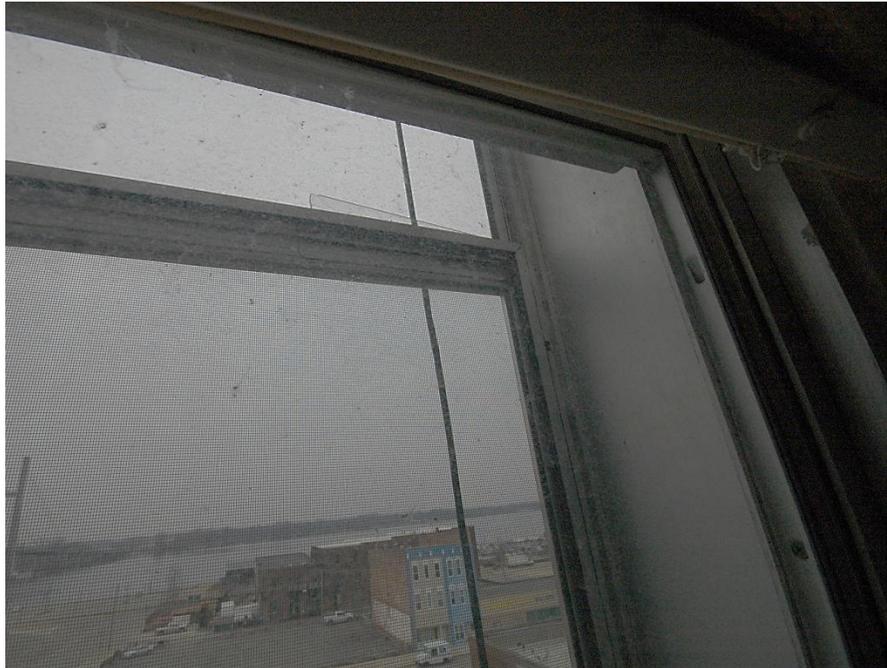
Image 1.1.5e

No insulation around
frame
Window Type III

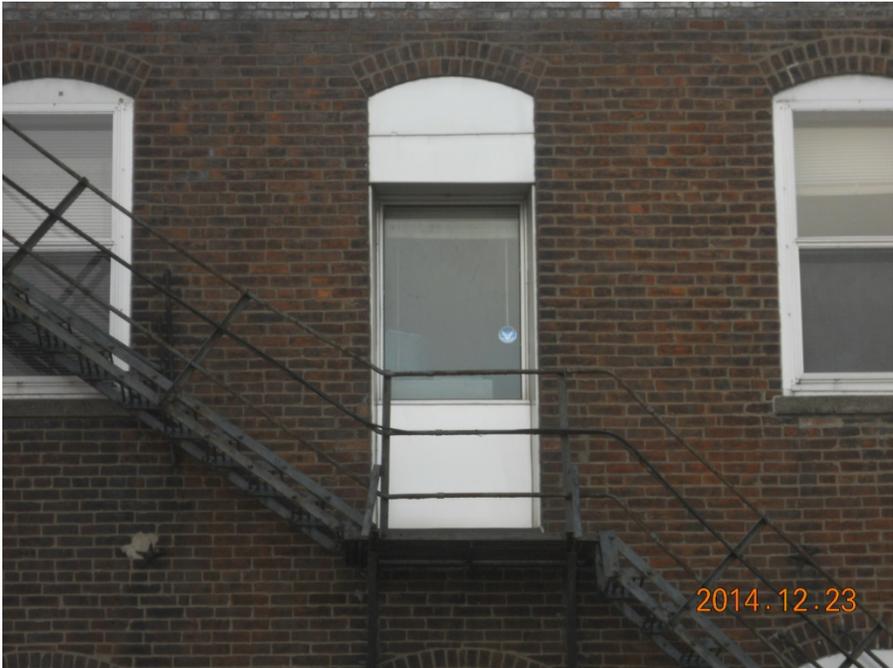
Image 1.1.5g

These openings are located on the East side of the building on the lower level and first floor. They consist of a vinyl replacement window. While in relatively decent shape the makeup of these windows marks them for a different visual look from the rest. Their sealant is also ageing; that along with a broken glass unit on the first floor allowing for moisture and air infiltration into the building (*Image 1.1.5g*).

Broken glass
Window Type V

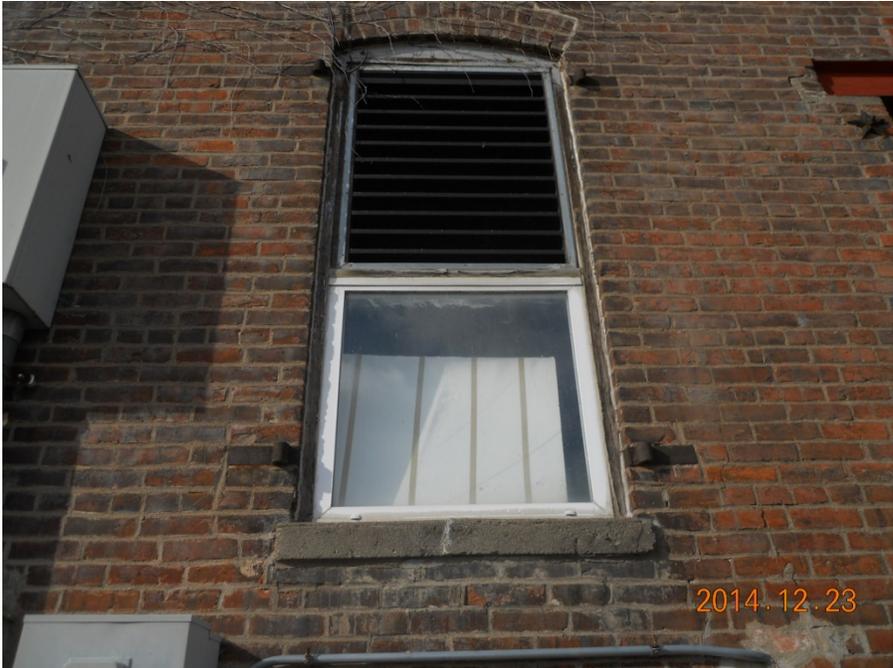
Image 1.1.6a

Failed caulking
Along North wall

5 to 10 Year Plan – Remove and replace all sealant along ramp, stair, entry door, and sign. When replaced, backer rod should be used to allow for two point adhesion in all joints. Remove wood; install backer rod and sealant in expansion joints. Remove sealant along bottom of stone sign and replace allowing for weeps. Patch and repair concrete

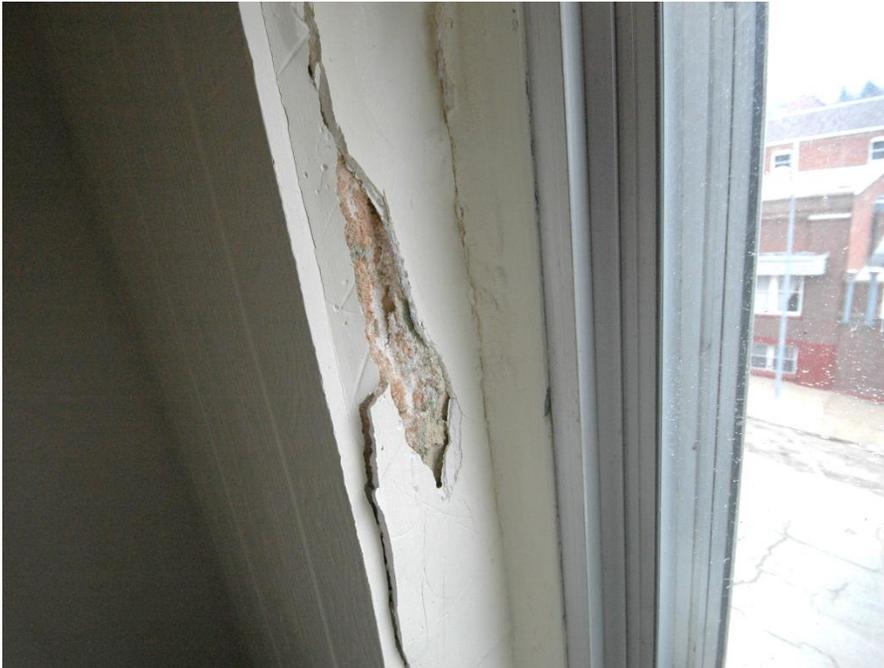
Image 1.2.1d

Plaster falling off wall
3rd floor stairwell

5 to 10 Year Plan – Basement; remove peeling paint off of exterior walls, apply a breathable wall coating as needed. 1st floor; patch plaster and gypsum and repaint with appropriate coatings as needed. 2nd floor; patch plaster and gypsum and repaint with appropriate coatings as needed. 3rd floor; clean up plaster that has fallen off wall and take steps to mitigate mold. Not much else is needed at this time due to lack of use of the space, if this space is to be used plaster will need to be patched and repaired and walls will need repainted with appropriate coatings.

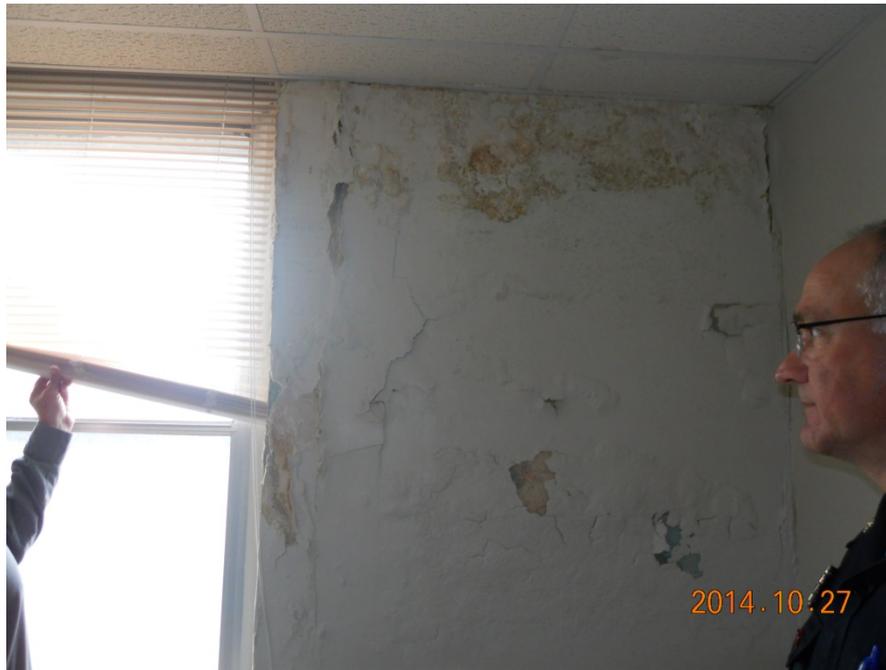
Image 1.2.1f

caused the formation of mold and mildew in the exterior rooms on this level (*Image 1.2.1f*).

Mold and mildew in
window
3rd floor North side

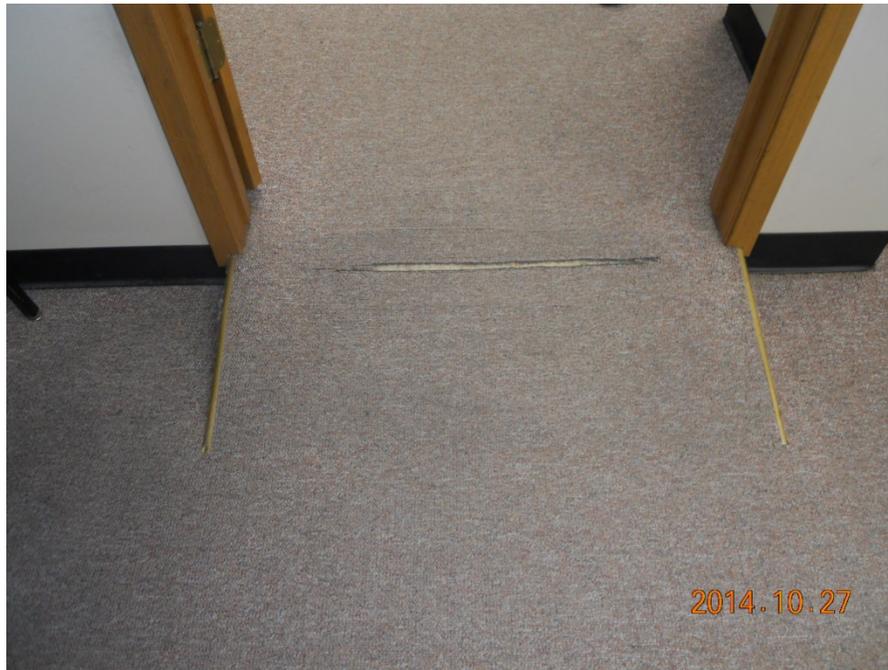
Image 1.2.3d

The two floor finishes viewed on this floor were again VCT and carpet. Most of the VCT on this floor was again in relatively decent condition, with some minor cracking. The carpet on this level was not in as good of condition. Issues of wear, traffic patterns, and sun bleaching were more apparent throughout all rooms on this level (*Image 1.2.3d*).

Stained and worn carpet
3rd floor

5 to 10 Year Plan – Basement; replace all carpeting in men's and women's locker room with a slip resistant tile 1st floor; replace the carpeting in the sergeant's room. Replace VCT and base in the lobby, reception, and main halls. 2nd floor; replace the carpeting in the office space on the Northwest corner. 3rd floor; take steps to mitigate moisture and mold. Not much else is needed at this time due to lack of use of the space, if this space is to be used carpeting would need replaced throughout.

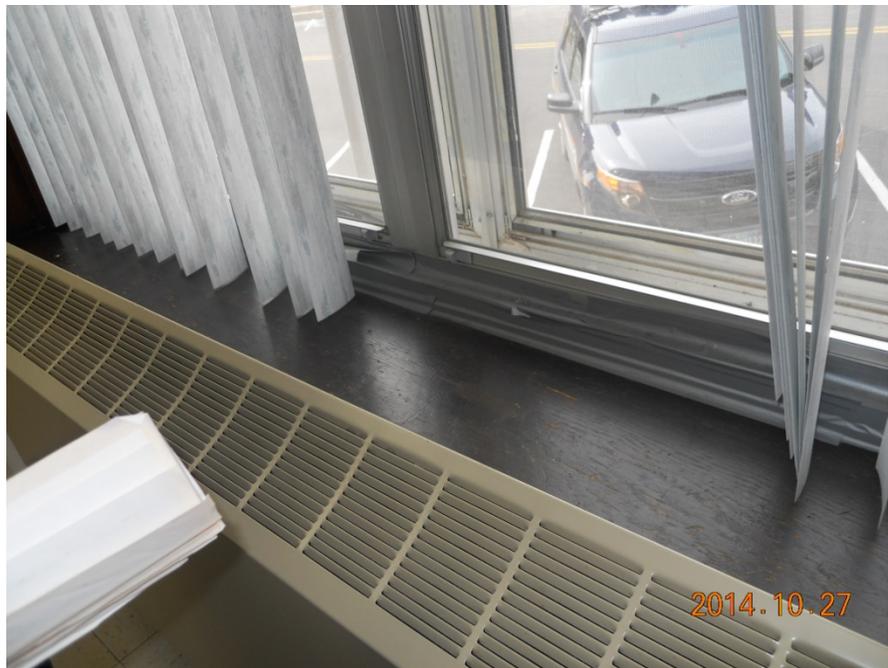
Image 1.2.4c

Windows used for display
Lobby

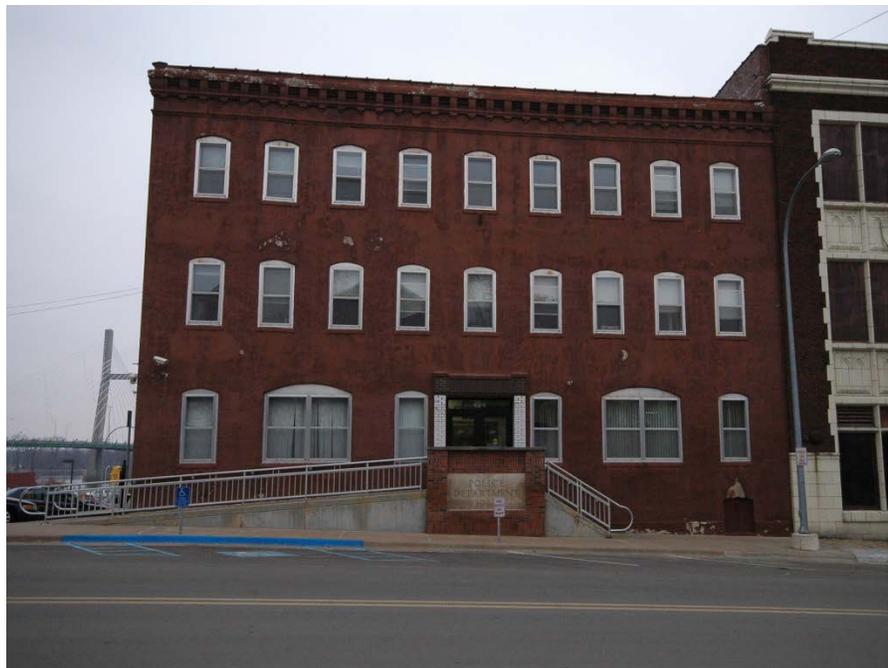
Image 1.2.6a

Rusty pipe, leak around
base of toilet

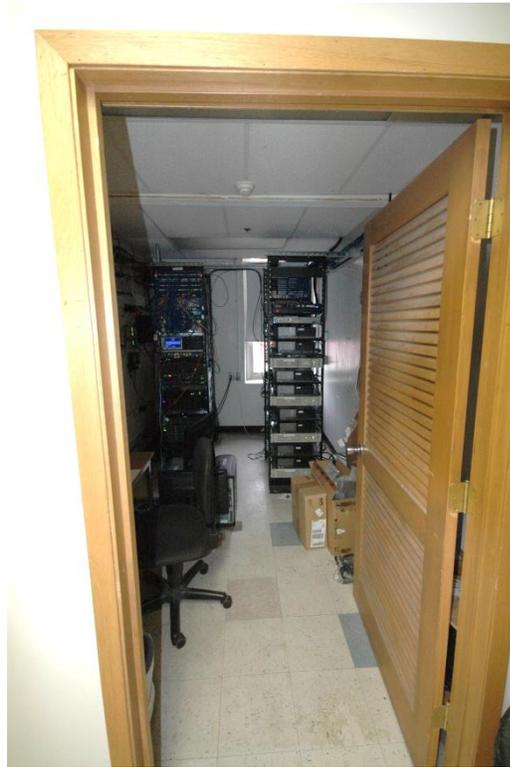
Image 1.2.8a

Broken VCT, small
evidence and armory

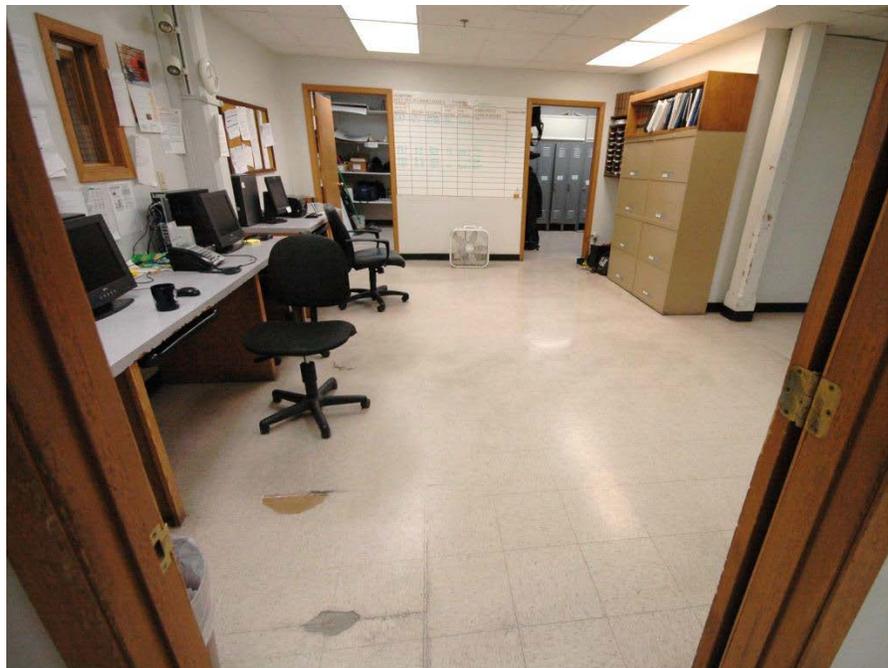
Image 1.2.8b

Lack of security and
workstations

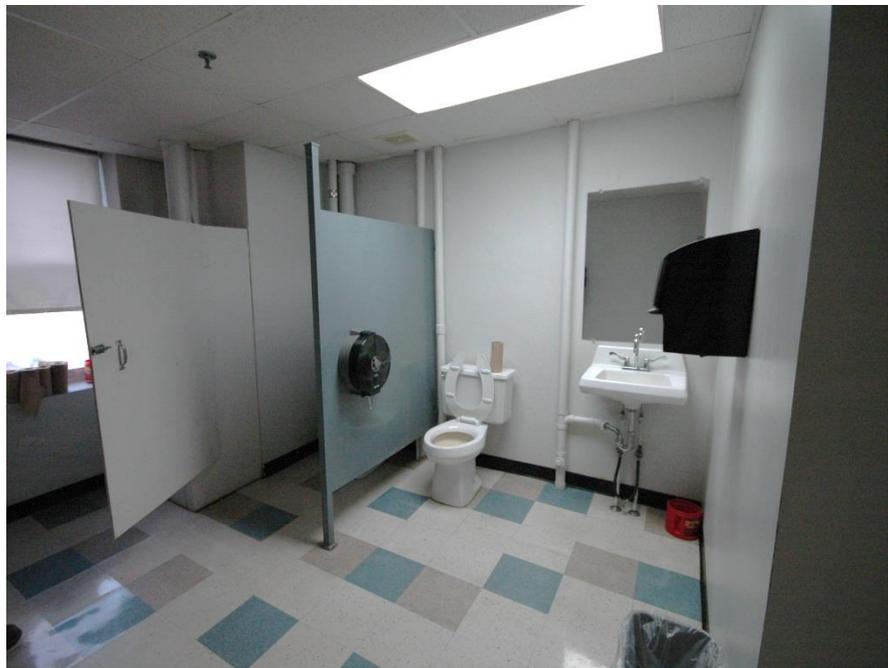
Image 1.2.11a

Wall deterioration
Men's locker room

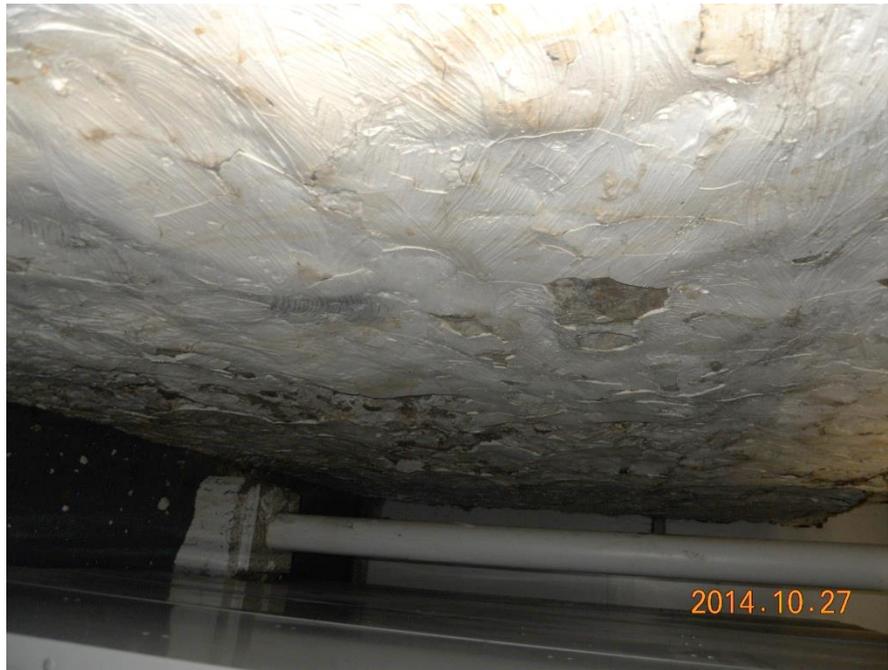
Image 1.2.11b

Panel deterioration and
mold at base of wall
Men's locker room

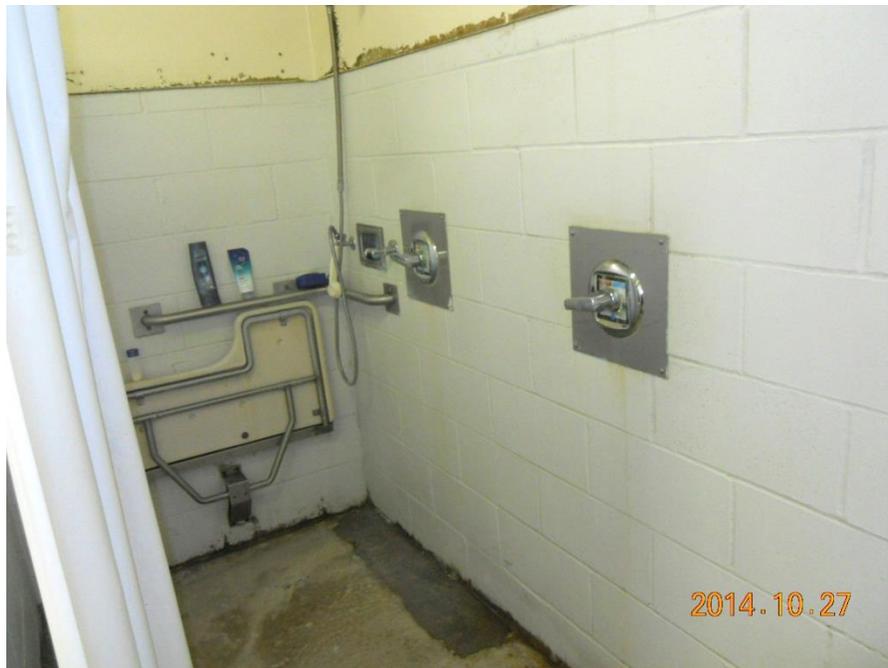
Image 1.2.11c

Lack of space
Men's locker room

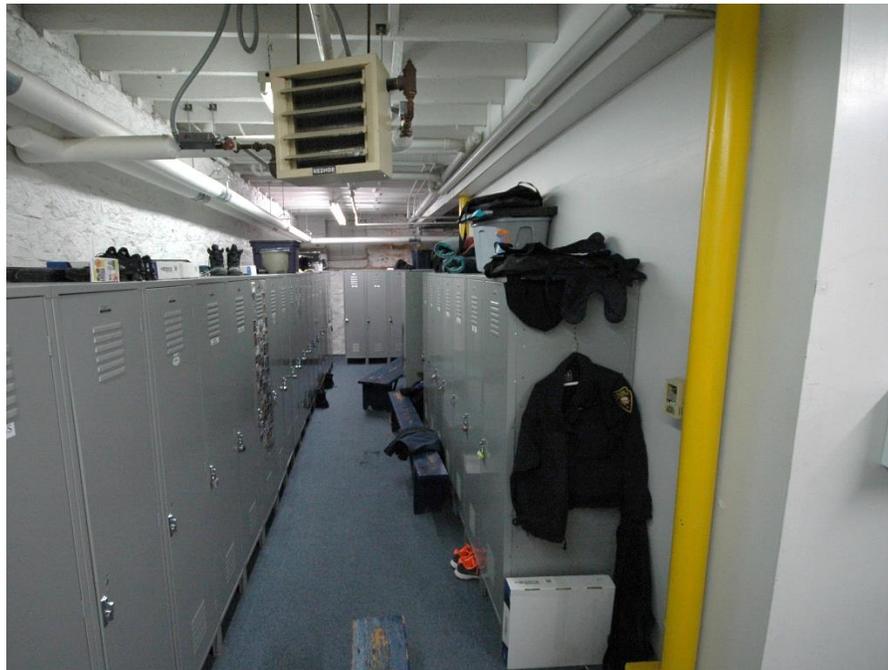
Image 1.2.11d

Substandard bathing
condition
Women's locker room

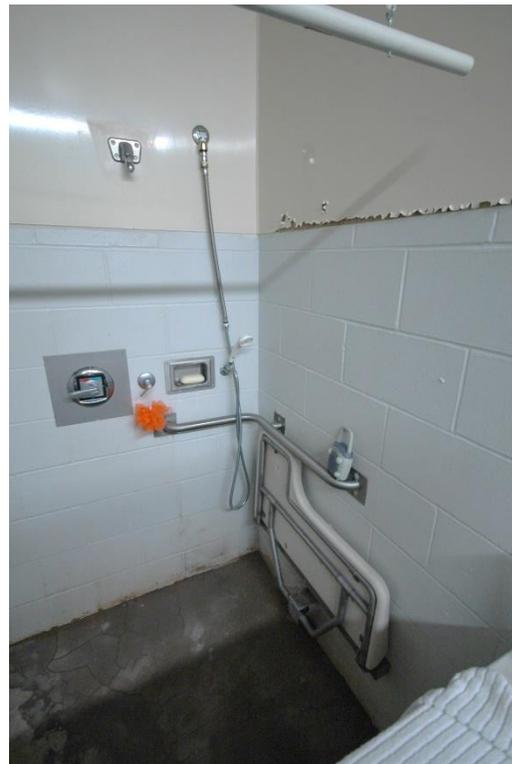
Image 1.2.11e

Lack of partitions
Men's locker room

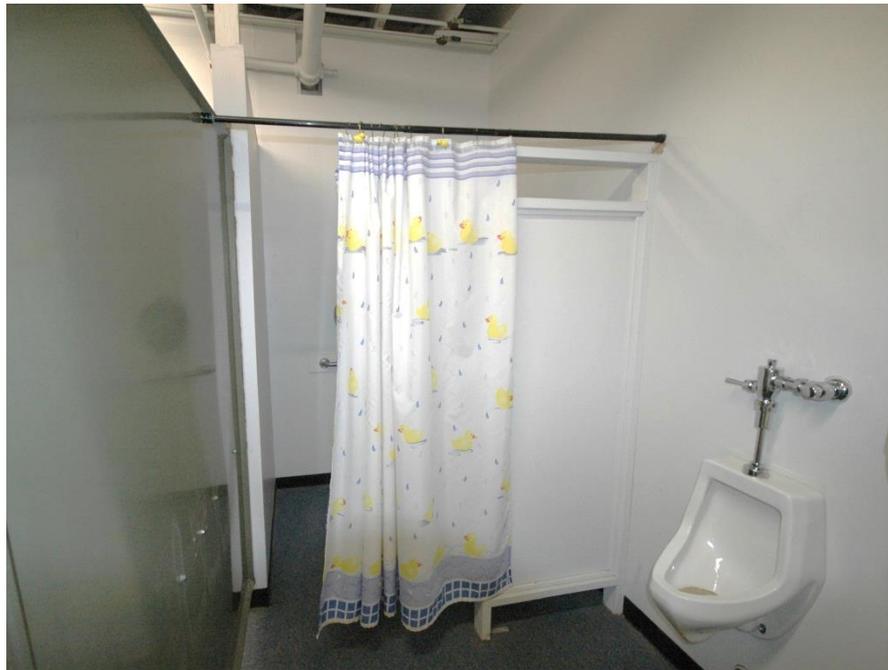
Image 1.2.11f

Lack of storage and
preparation space
Women's locker room

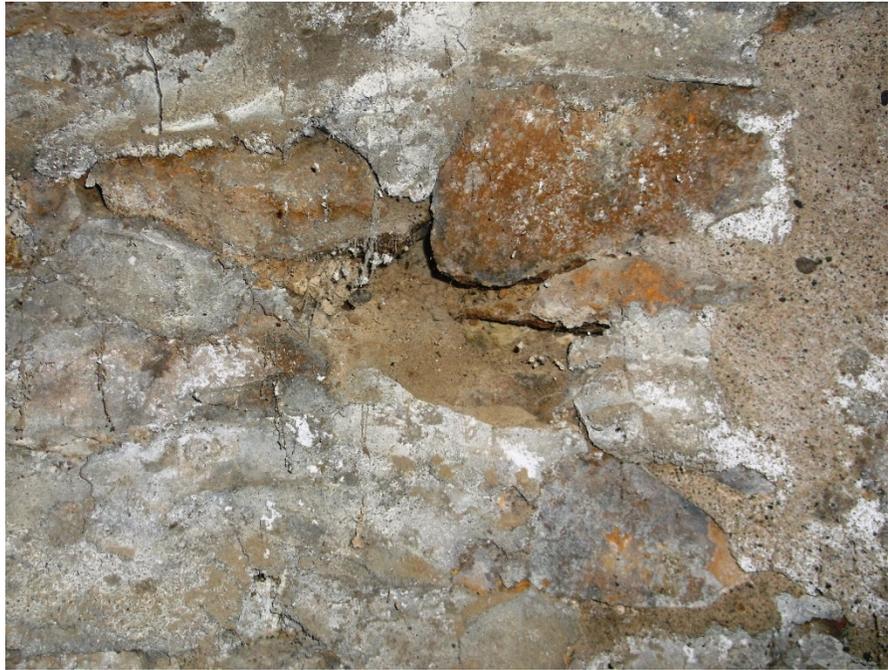
Image 2.2a

Exterior wall plaster
damage
3rd Floor North wall
