FEASIBILITY STUDY

Burlington Police Department
Burlington, Iowa

January 23, 2015

Klingner & Associates, P.C.

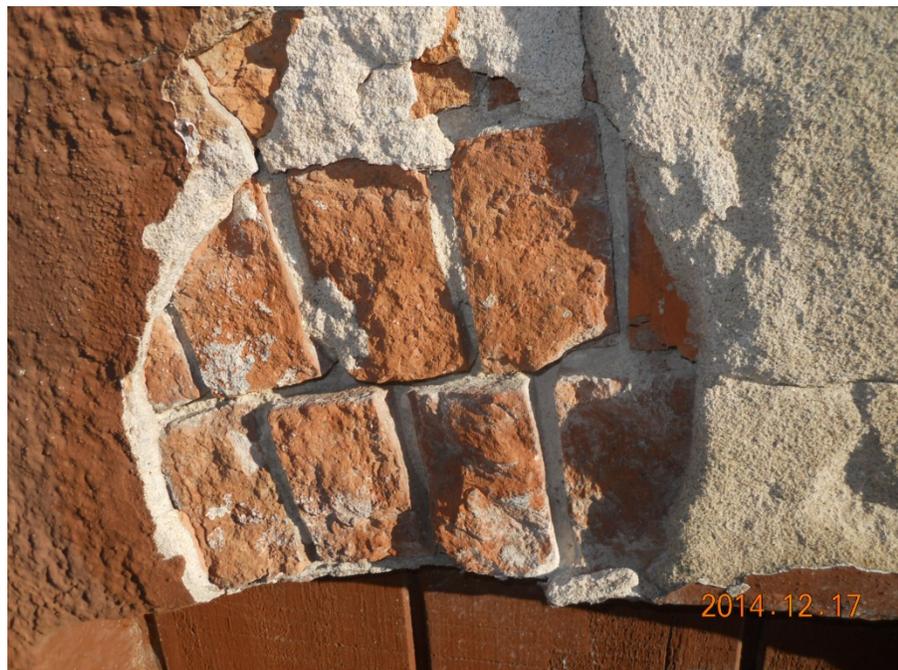
Image 1.1.2f

Damaged brick
West Façade

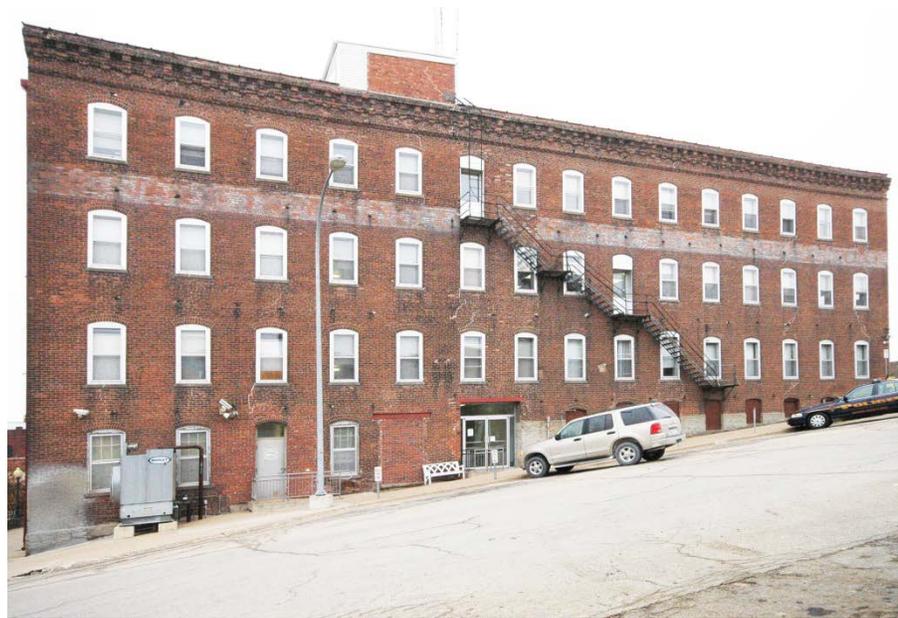
Image 1.1.2g

North Façade
Signage band

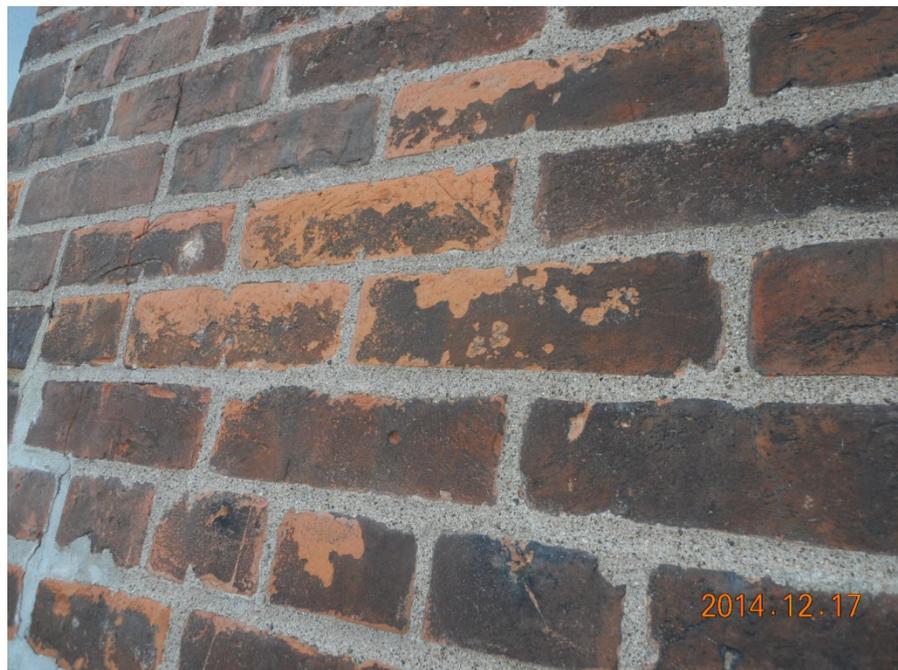
Brick spalling

North Façade

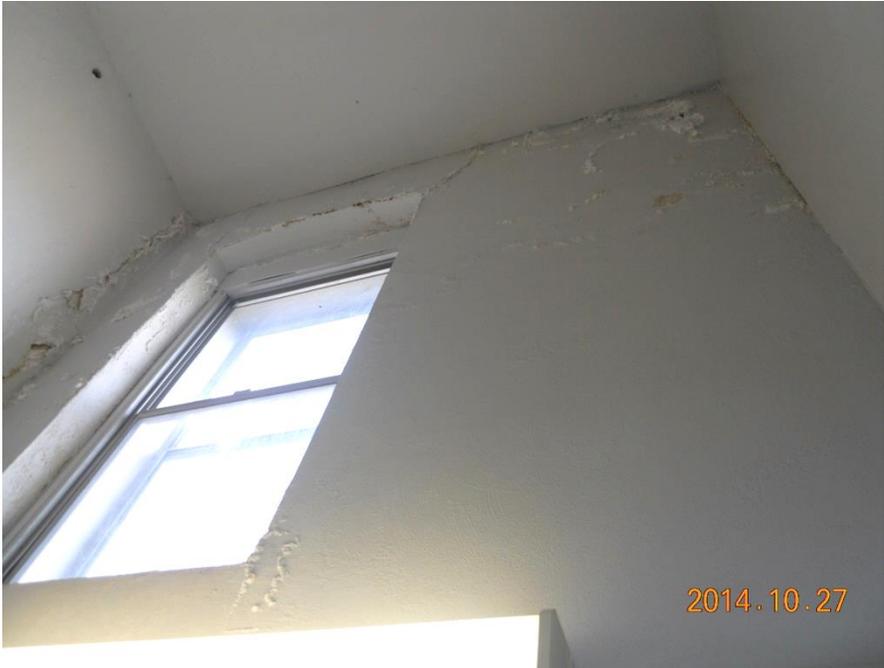
Image 1.2.1d

Plaster falling off wall
3rd floor stairwell

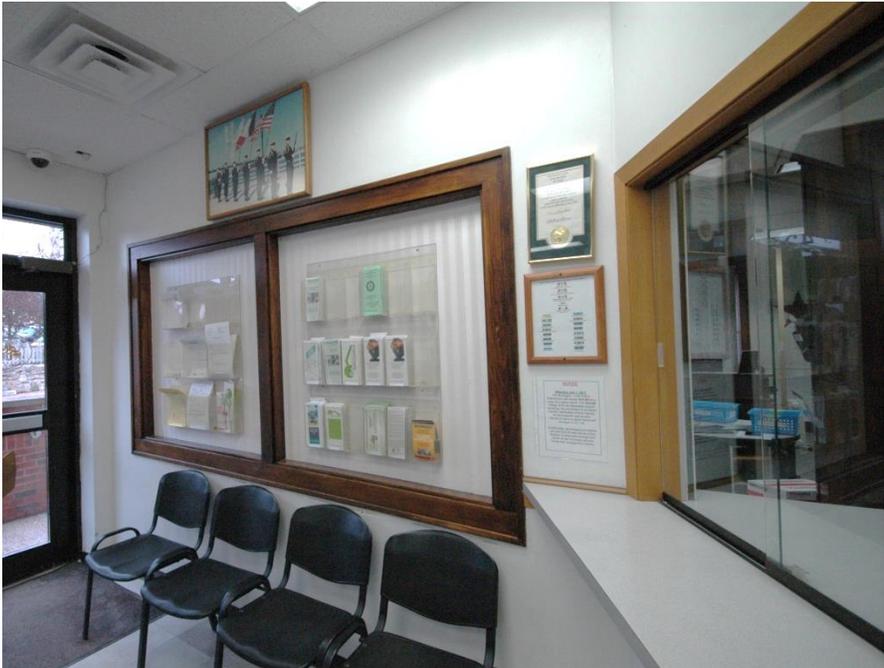
Image 1.2.4c

Windows used for display
Lobby

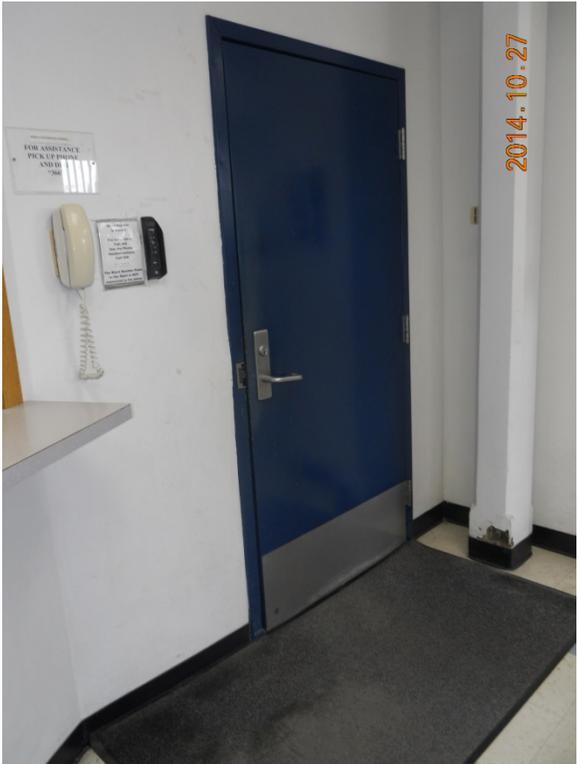
Image 1.2.4d

“Secure” door and keypad
Lobby

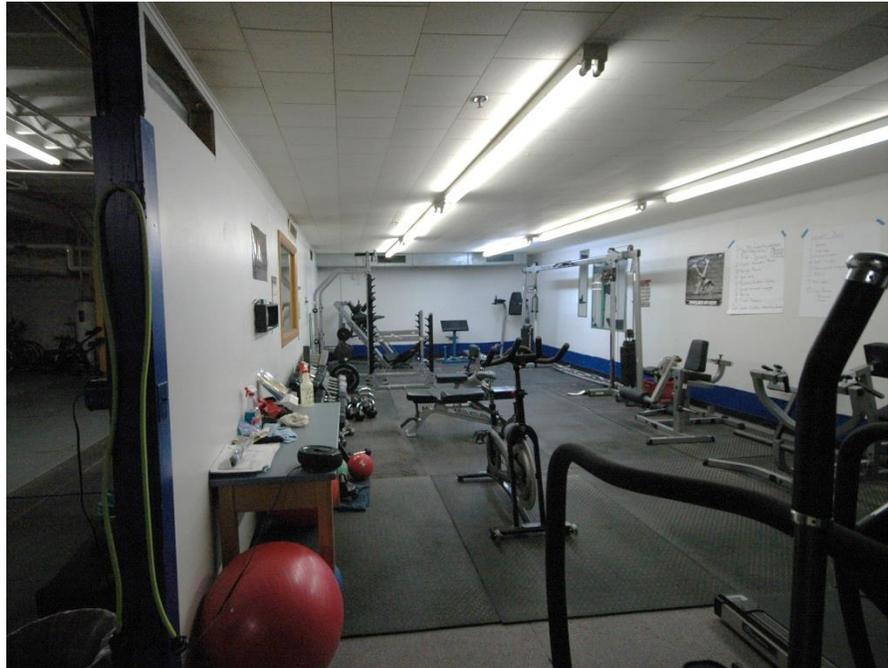
Image 1.2.12a

Lack of space unused
duct work
Exercise room

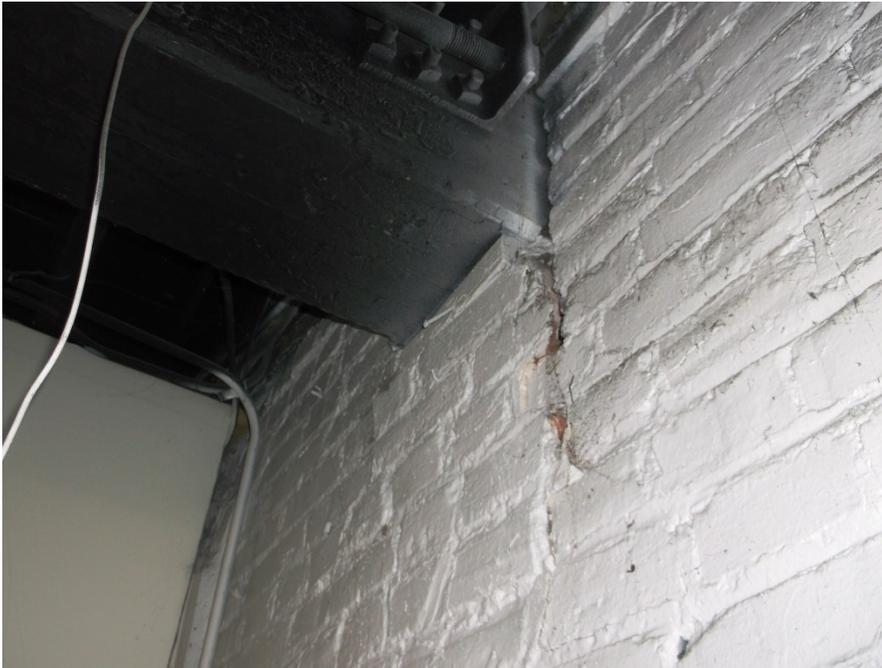
Image 2.2b

Major structural repairs are needed in the exterior walls. The two issues that need to be dealt with ASAP are moisture and movement. First, moisture is entering the wall causing the deterioration of both the brick on the exterior along with the plaster on the interior (*Image 2.2a*). Second the walls, especially the East wall, are moving. This is evident in brick walls cracking where beams are being supported (*Image 2.2b*), and the East wall pulling away from interior walls and floors (*Image 2.2c*). In addition, on the East wall, masonry has been replaced between the 3rd and 4th floors on the north side of this façade (image 1.1.2k and 1.1.2l). As mentioned earlier, the replaced brick is 3” out of plumb with the roof parapet. Layers of bond bricks (bricks that tie multiple layers (wythes) of bricks together) are present. However with this much movement, the bond bricks may be broke inside the wall and thus not tying the wall together properly.

Exterior wall pulling
away from supporting
beam

Basement

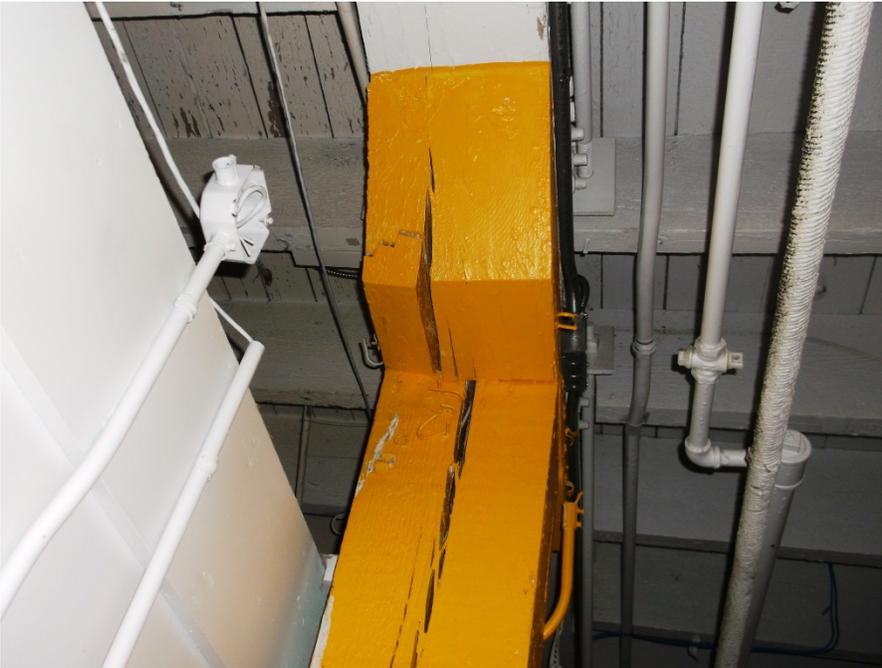
Image 2.3a

The heavy timber frame in the building is in relatively decent shape and looks to be in sound condition. There are a few columns, capitols, and beams that are showing radial shrinkage cracks (*Image 2.3a*). Radial shrinkage cracks are cause by stress on the timbers as the wood dries and are not structural issues. The issue is that some of the cracks have opened up quite far.

Radial shrinkage cracks
Basement column and capitol

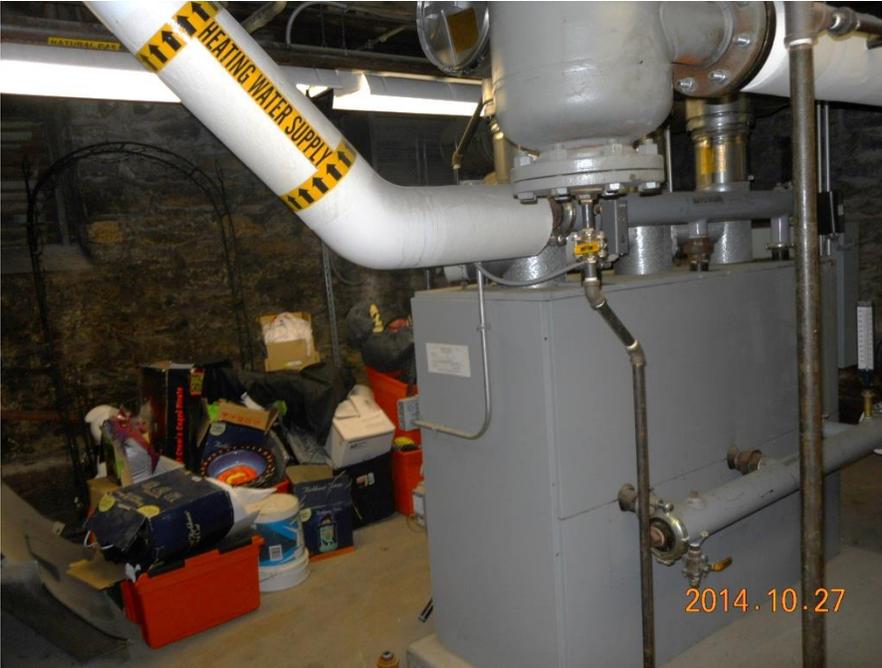
Image 3.1.1a

Heating water for the building is generated by a series of natural gas fired water heaters (*Image 3.1.1a*). A pair of constant volume hot water pumps provide flow to piping routed throughout the building. During the site visit the outdoor air temperature was mild and the system was generating 135°F water. Based on visual inspection and discussion with maintenance personnel it appears that the mechanical equipment is well maintained. The system was installed during the 1993 renovation making it about 21 years old. With the current maintenance program the boiler system can be expected to last another 10 to 15 years before major repairs or replacements are necessary.

Boiler
Sub-Basement

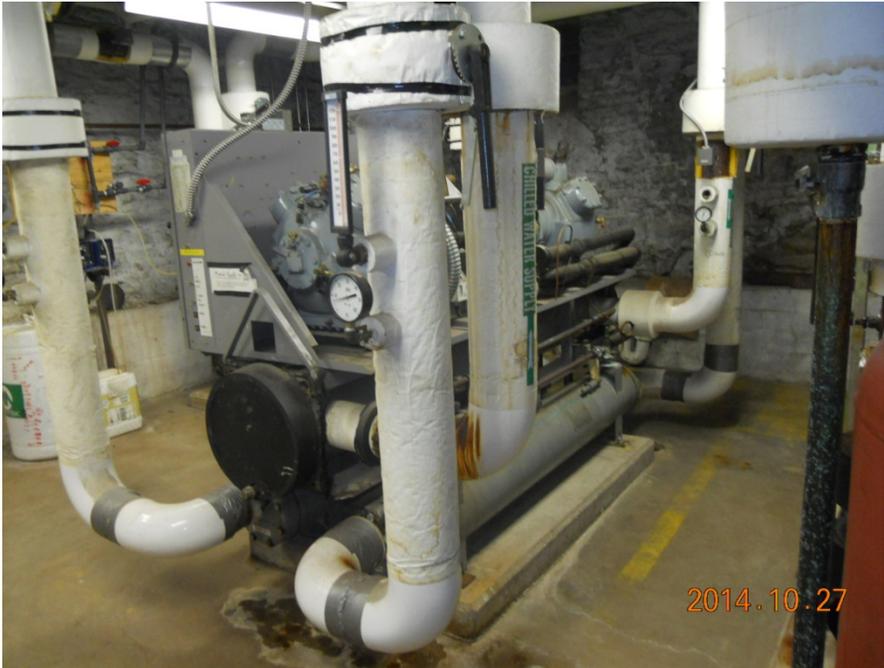
Image 3.1.1b

Chilled water used for air conditioning in the building is generated by a chiller located in the lower level mechanical room (*Image 3.1.1b*) with a cooling tower located on the sidewalk on the north side of the building (*Image 3.1.1c*). A separate set of constant volume pumps provide flow to a piping system separate from the heating water system. The chiller was not operating during the site visit due to the cool outdoor air temperature. It is assumed that cooling water is supplied at around 55°F when the system is operational. The cooling tower water reservoir was recently replaced to repair corrosion due to equipment age. Visual inspection reveals that the cooling tower in general is in poor condition. Many of the channels have corroded away and maintenance noted that the unit requires replacement. The chiller itself appears to be in good condition and can be expected to function for an additional 10 to 15 years before major repairs or replacements are necessary.

Chiller
Sub-Basement

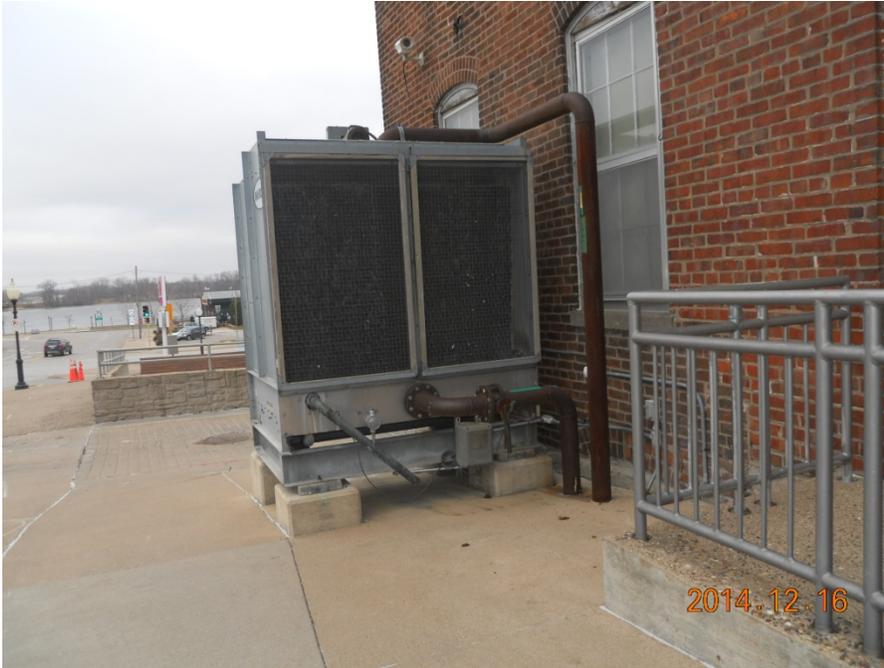
Image 3.1.1c

Cooling Tower
Exterior Northeast
corner

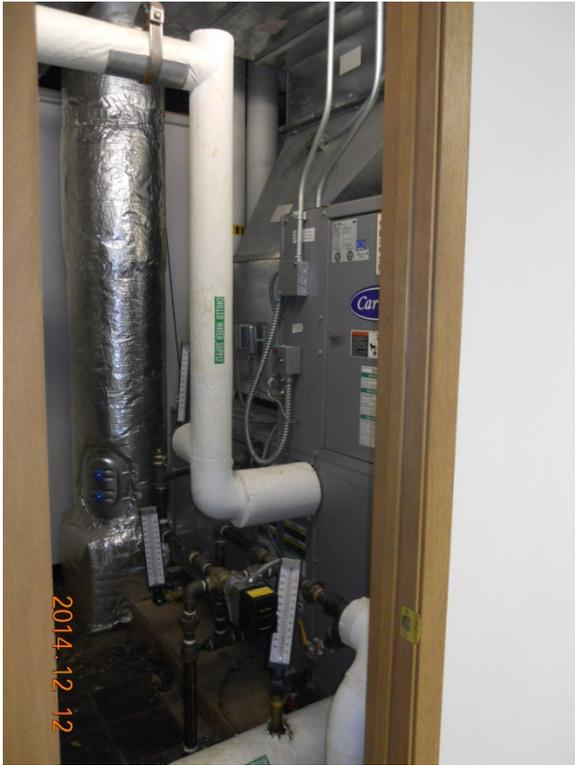
Image 3.1.2a

Each of the building's top three floors are provided with an air handling unit (AHU) to supply conditioned air (*Image 3.1.2a*). The AHU is connected to fresh air duct and it contains both a heating and a cooling coil connected to the central heating and cooling systems. The supply fan is capable of varying the supply air flow rate by using a variable frequency drive (VFD) adjust the speed of the fan. The water temperature to the heating and cooling coils is adjustable through the use of three-way control valves.

Air Handling Unit
Typical of 1st, 2nd, and
3rd floors

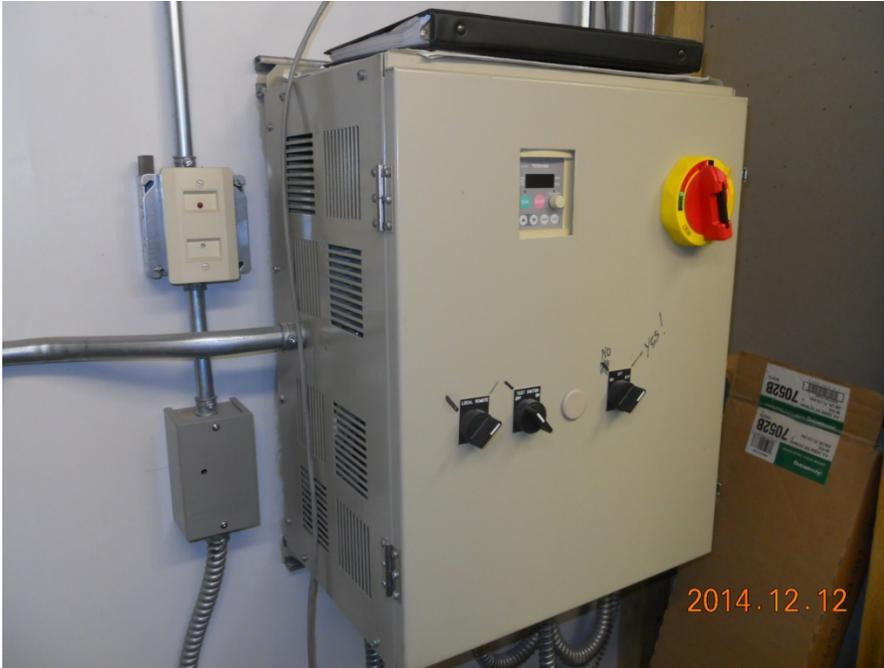
Image 3.1.5a

When the building was renovated in 1993, a Honeywell electronic temperature control system was installed (*Image 3.1.5a*). The purpose of a control system is to automate control of the boiler and chiller system as well as the AHU, VAV boxes, and unit heaters to improve both occupant comfort and energy efficiency. Based on the control equipment installed, the boiler and chiller are capable of varying supply water temperatures depending on the load of the building. The AHU is capable of varying the supply air quantity and temperature to meet requirements of the zones it serves. The VAV boxes allow space temperature control by varying quantity and temperature of the air to the specific zone.

Honeywell Temperature
Control System
Installed in 1993
